Building Codes Division

Minor Label Inspection Photo Guide

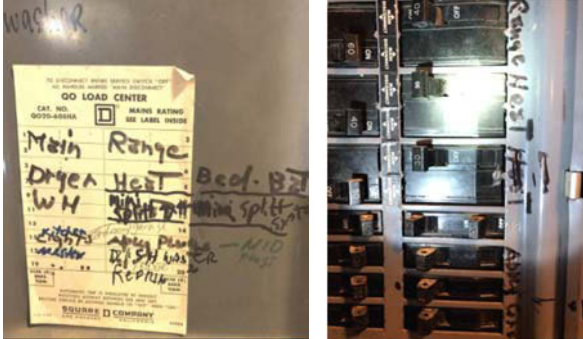
Description	What to provide in photograph	Sample photo (sample photos size is reduced for this document)
<p>Breaker panel and label</p>	<ul style="list-style-type: none"> • Provide a picture of the breaker verifying it has been properly labeled • Verify the amperage rating is visible in the picture

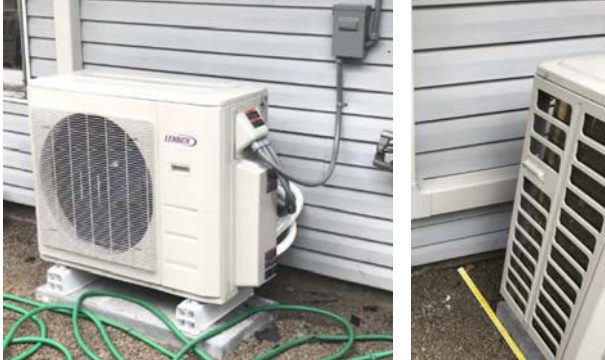
<p>Condensing unit</p>	<ul style="list-style-type: none"> • Provide a picture showing unit is supported properly, required clearances are met (tape measure must be shown) • If a fused disconnect is used, provide a picture of the fuses showing the amperage rating

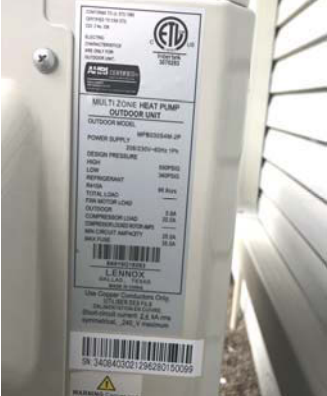
<p>Electrical circuit requirements label</p>	<ul style="list-style-type: none"> • Provide a readable photo of the full label, showing manufacturer, model number and install specs

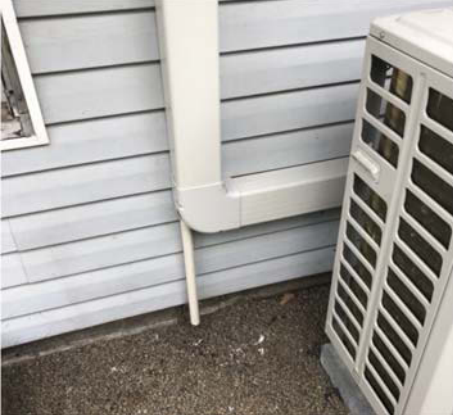
<p>Condensate drain tube</p>	<ul style="list-style-type: none"> • Provide a picture of the drain termination location • If there is more than one condensate drain, provide a picture of each termination

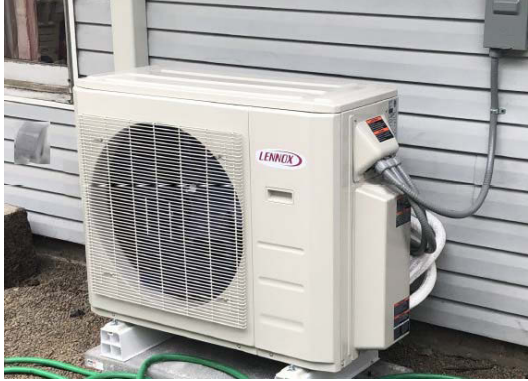
Description	What to provide in photograph	Sample photo (sample photos size is reduced for this document)
<p>Service receptacle</p>	<ul style="list-style-type: none"> Provide a picture demonstrating that there is an electrical outlet within 25 feet of the condensing unit
